## FLIGHT EXPERIENCE WITH A DELTA-WING AIRPLANE HAVING VIOLENT LATERAL-LONGITUDINAL COUPLING IN AILERON ROLLS

By Thomas R. Sisk and William H. Andrews

High-Speed Flight Station
Edwards, Calif.

October 7, 1955

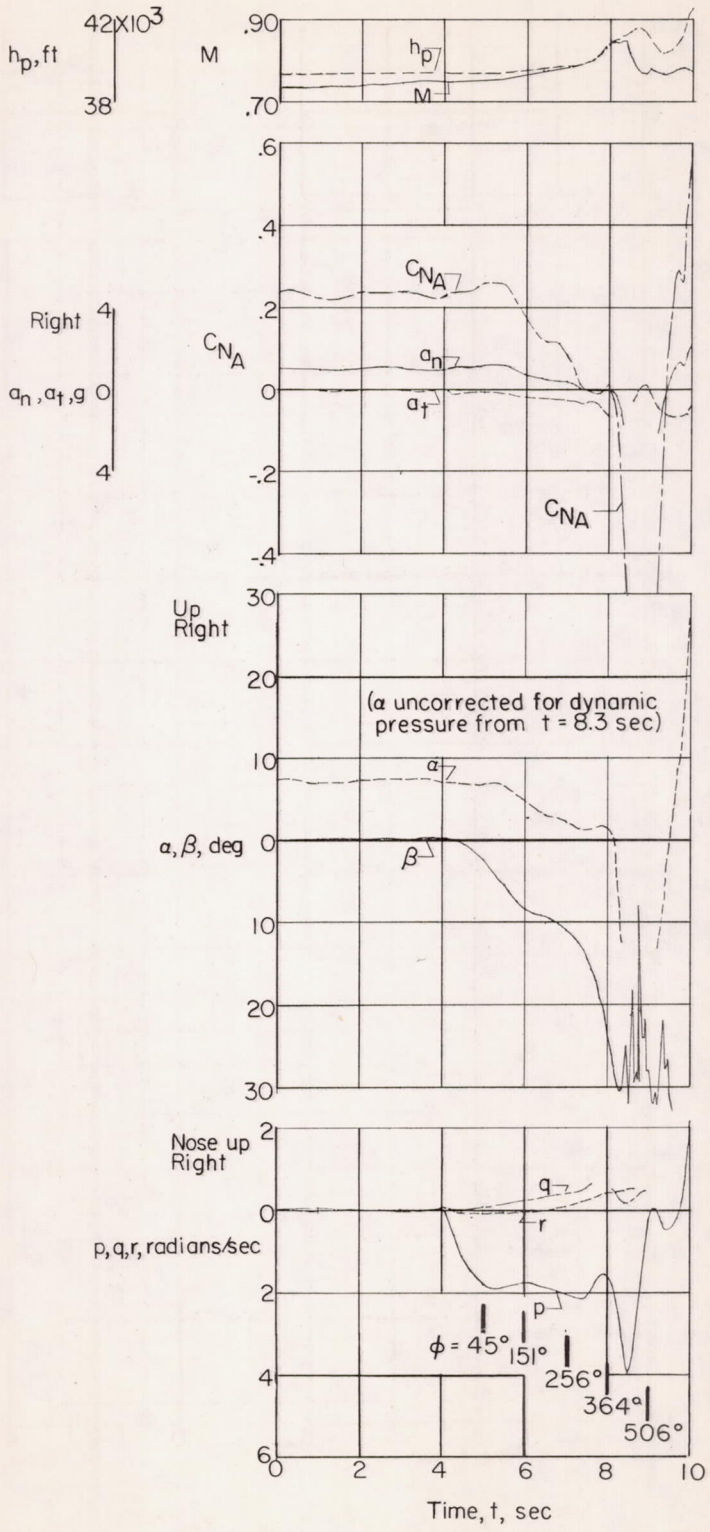
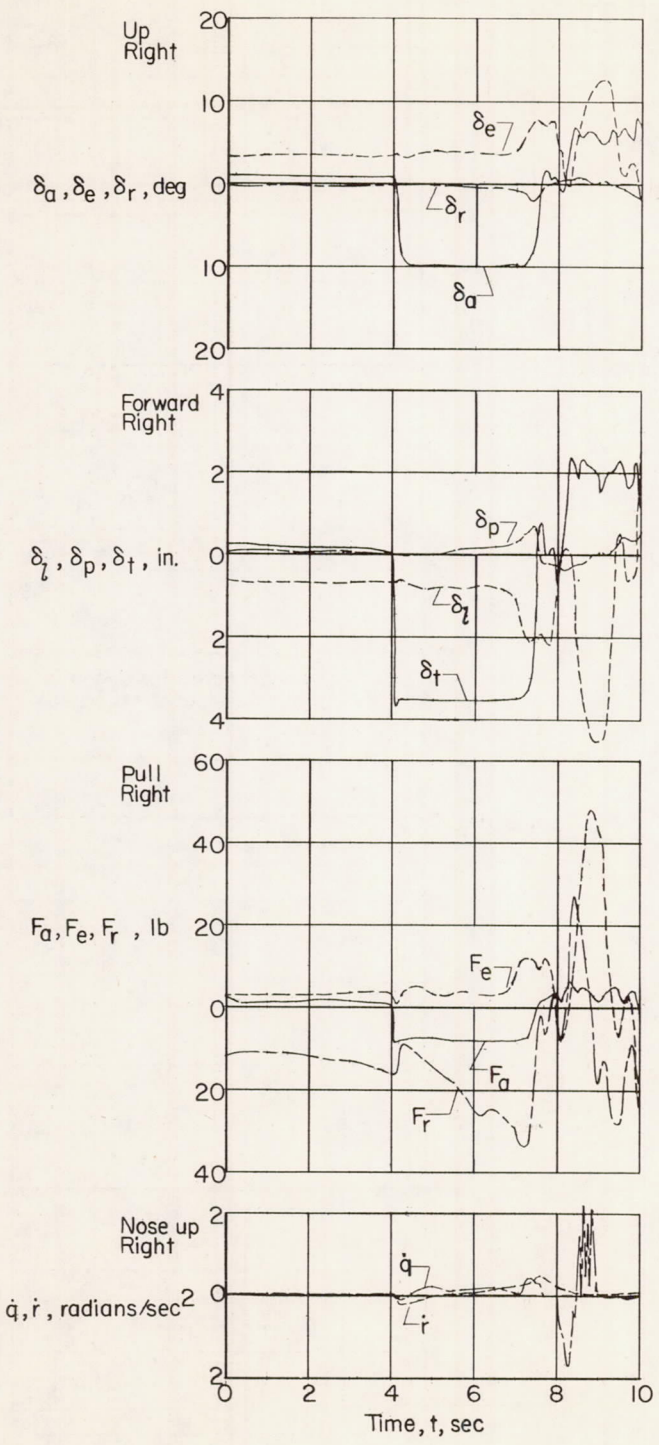
Figure 4.- Time history of half deflection aileron roll in which airplane became uncontrollable. M = 0.75; $h_p$ = 39,500 feet.

Figure 4 presents a time history of an aileron roll, performed at a Mach number of 0.75, in which the airplane became uncontrollable. The altitude and center-of-gravity position were approximately the same as for the other rolls presented. The initial bank angle was approximately 20° right. An inspection of the time history reveals that the behavior is initially very similar to the other maneuvers, particularly those at M = 0.80, with adverse sideslip developing when the roll started. Recovery from the maneuver was initiated at 7.3 seconds. At this time the angle of sideslip increased very rapidly from 12° to 30° and the angle of attack decreased to 13° down where it exceeded the instrument range. The roll velocity had attained a value of 2.0 radians per second and began to decrease at the initiation of recovery; however, as the angle of attack became more negative and sideslip increased, the roll velocity also increased to approximately 4.0 radians per second. As a result of the increased roll velocity, the angle of bank continued to increase from 360° to 500°. The normal acceleration trace exceeded the instrument range at -2.6g, but the g-indicator in the cockpit reached its stop at -5.0g. During this maneuver the recorded maximum transverse acceleration was 1.3g at which point the acceleration exceeded the limit

of the instrument. This load factor considerably exceeded the placard of 0.95g. The maneuver continued beyond the 10 seconds time shown on the time history, but because of a shift of the electrical power to the emergency system, the instrument power was automatically cut off.

The pilot (who had also performed aileron rolls in the airplanes of ref. 1) objected to the roll maneuvers in the delta-wing airplane as being exceedingly uncomfortable. He described the rolls as feeling much like the maneuvers of the swept-wing fighter of reference 1. He felt the momentary hesitation in the development of sideslip which had been encountered in previous controllable manuevers and therefore permitted the roll to continue. Shortly thereafter the pronounced divergence in sideslip began and recovery attempts were initiated. Inspection of figure 4 substantiates the pilot's impressions in that at about time 6.25 seconds the angle of sideslip begins to stabilize, leading him to believe that maximum sideslip had been reached.

Violent cross-coupled lateral and longitudinal motions of a delta-wing fighter-type airplane were encountered during an abrupt, rudder-fixed aileron roll at a Mach number of 0.75.

These motions produced large variations in angle of attack and angle of sideslip which resulted in load factors as large as 5g (negative) normal acceleration and 1.3g transverse acceleration.

Further calculations are being made (using, wherever possible, stability derivatives obtained from flight data) to determine the extent to which the divergent tendencies of the subject airplane in rolling maneuvers can be alleviated through rational design modification. It would appear from a preliminary study that an increase in directional stability would be beneficial.

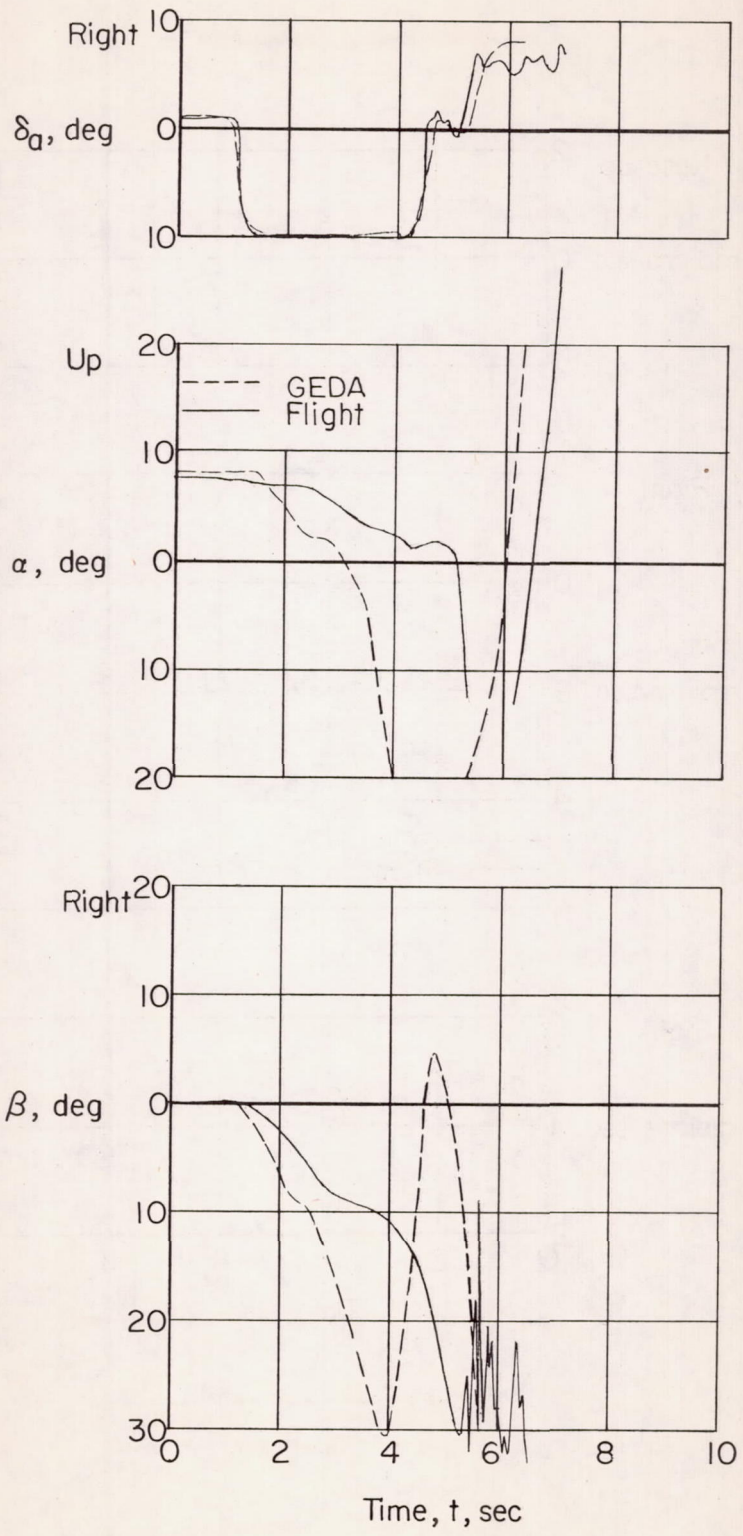
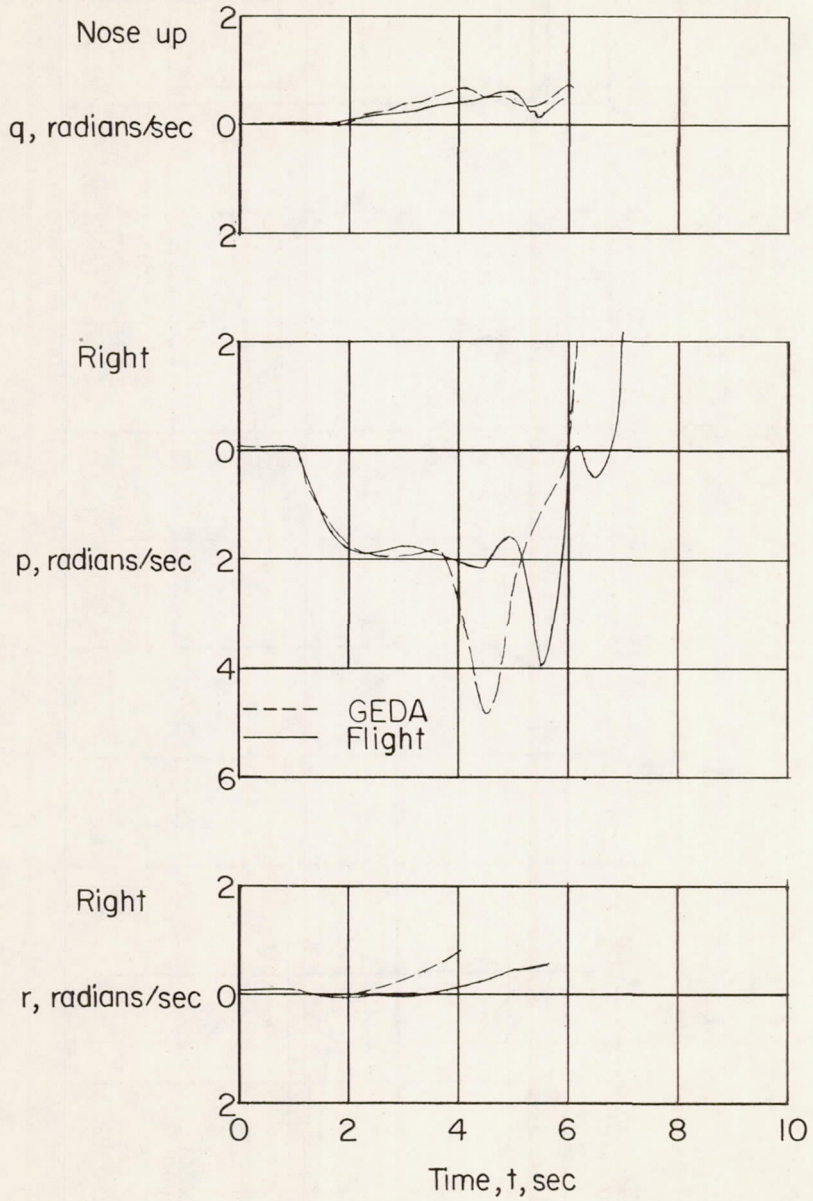
Figure 5.- Comparison of the maneuver of figure 4 with Goodyear Electronic Differential Analyzer simulation.

At the time the maneuver of figure 4 was encountered, a 5-degree-of-freedom analytical study of the characteristics of the airplane in rolling maneuvers was being initiated using a Goodyear Electronic Differential Analyzer. These general studies were to be used as a guide in extending the flight program to more critical conditions. Some preliminary work has been done on the GEDA in an attempt to match the flight records of figure 4. A typical comparison of the flight and computed results is shown in figure 5. (A summary of the derivatives used is presented as table II.) Although the degree of fit is quite poor, the basic divergent tendencies were manifested in the calculations. The poor simulation is, perhaps, not too surprising in view of the absence of lateral stability information for the cambered-reflexed wing configuration, which necessitated the use of uncambered wing-configuration derivatives.

A preliminary 5-degree-of-freedom analog study of this maneuver indicated that basic divergent tendencies might be expected.
